**Arundo Removal and Replacement Team
2019 Monitoring Report**

CDFW File #: 1#: #1600-2018-0287-R3

July 2020

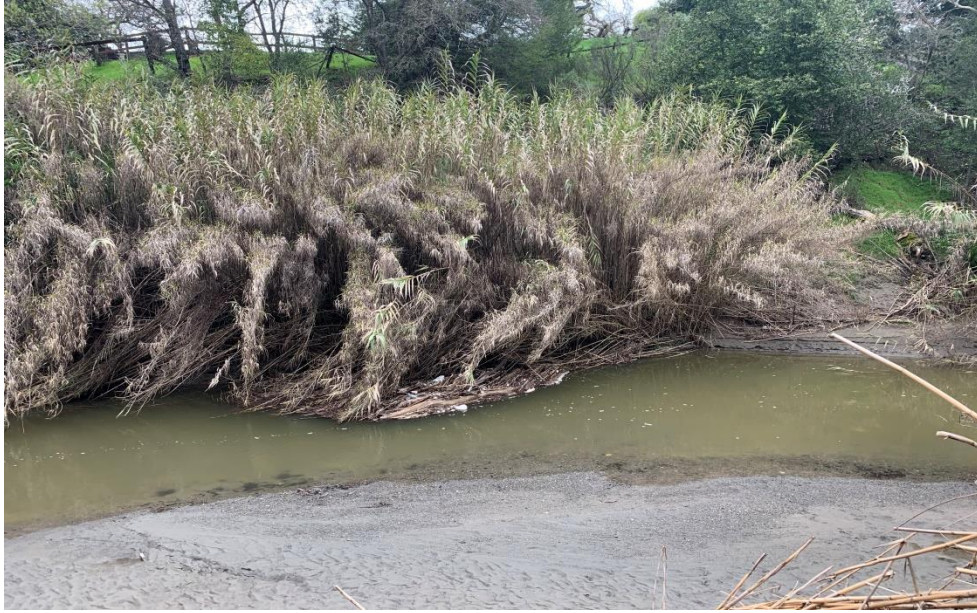
View 1. San Ramon Creek site in June 2018. Note the large Arundo stand at the site center.

In 2018, the Arundo stand had been cleared by volunteers and Trust contractors. No herbicide spray was used on the Arundo, and the stand grew back to its original height (though not the same high density) quickly. In early December 2019, the stand was cut and all the non-native vegetation on site was cleared (View 2) and placed in a dumpster.

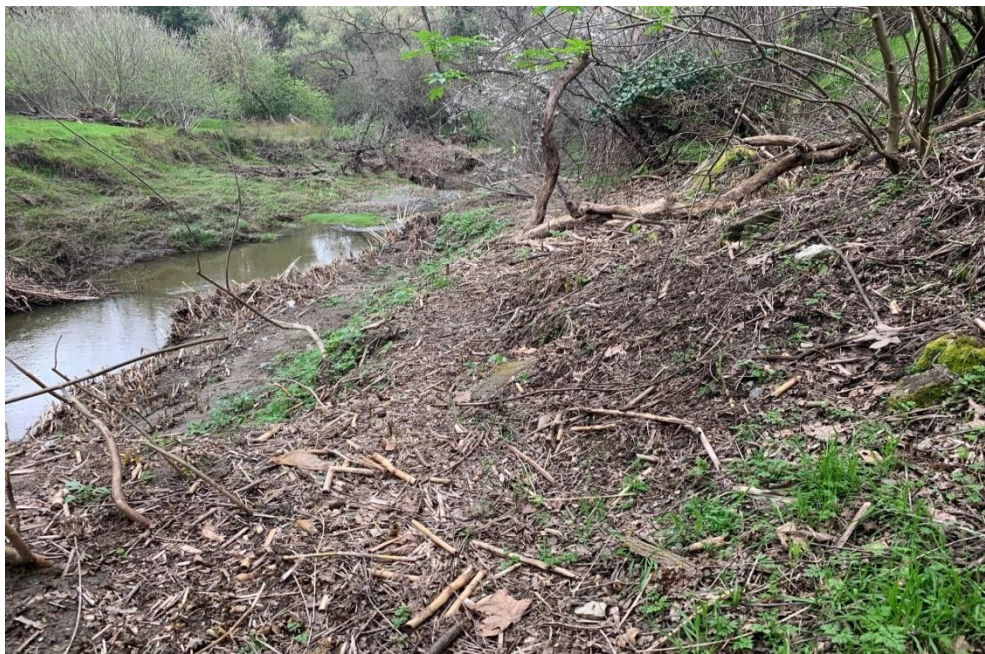
View 2. San Ramon Creek site in December 2019, following clearance of Arundo and other invasive plants.

Shortly after the Arundo was cut and cleared in December, the Arundo stubs were sprayed with a 41% solution of glyphosate to control reemergence. In mid-December, 20 community volunteers planted almost 5,000 plugs: 2,000 valley sedge plants and 3,000 creeping wild rye plants. The terrace at the top of the site was densely planted with creeping wild rye, and the steep slopes below were planted in scattered clumps with the sedge.

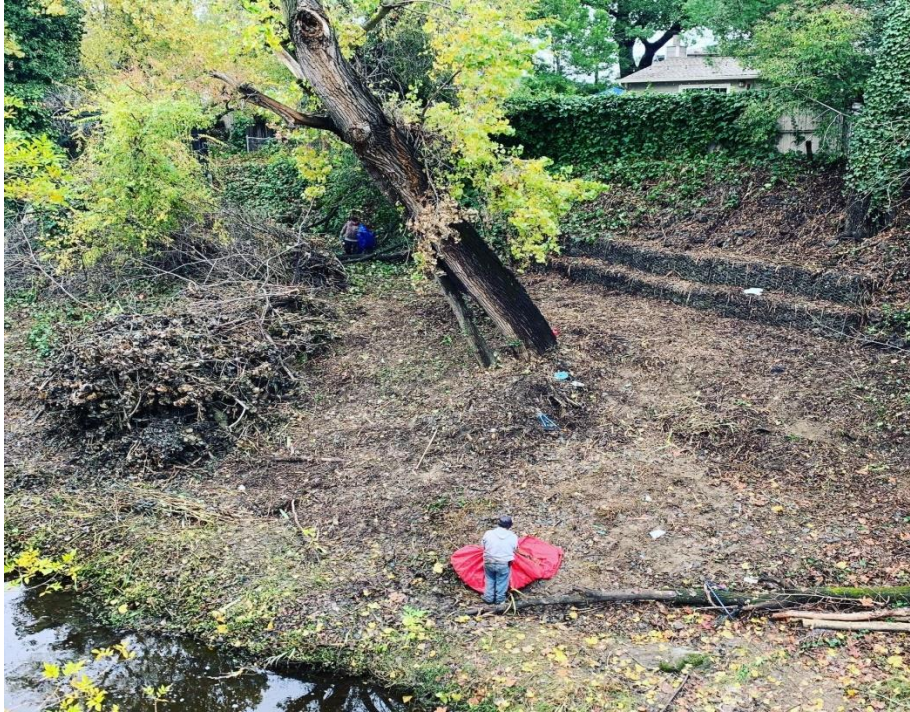
View 5. Walnut Creek site after clearance. The leaning cottonwood tree in the center provides a reference point to compare the cleared site with the pre-cleared site shown in View 4.

We began site clearance in early December 2019. Accessing the site was very difficult, but we created a series of steps down the slope to make access easier. A 60 cu. yd. dumpster was filled with *Arundo*, ivy, and other invasives. The cut *Arundo* was then sprayed in late December with Roundup at the manufacturer's rates (3%). View 5 shows the cleared site.

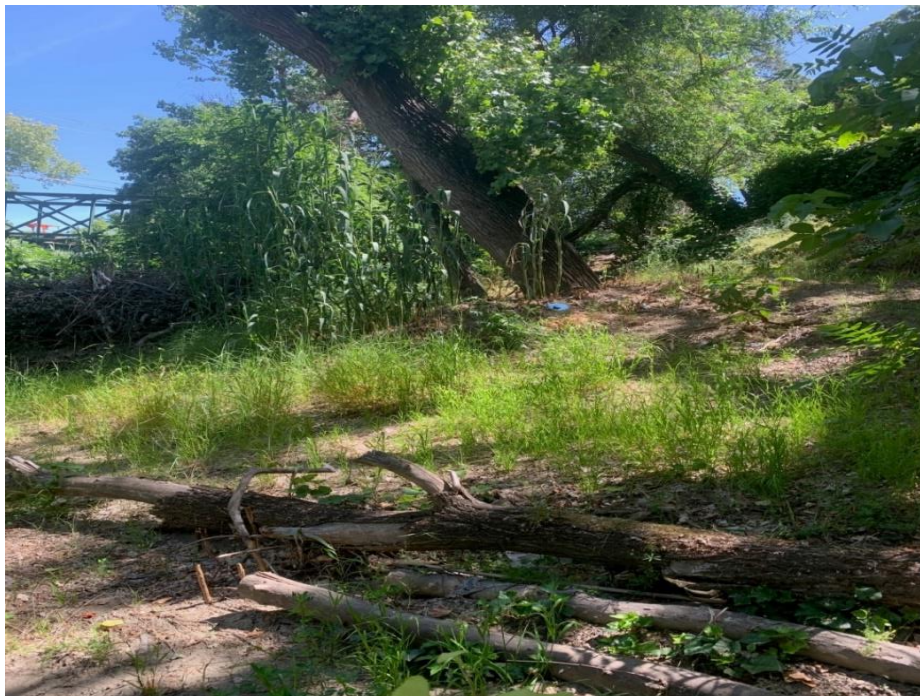
View 6. Walnut Creek site in May 2020. The grass in the center of this photo is creeping wild rye. Note the leaning cottonwood tree that appears in previous Views. Arundo can be seen resprouting to the left of the tree.

Absolute plant cover at this site is relatively low due to the extent of sandy soils, which tend to be problematic for seedlings due to drought stress. That said, native cover is relatively high, as the planted perennials favor sandy soils. Additionally, several natives including mugwort (*Artemisia douglasiana*) are appearing and colonizing patches at the site. The cover by exotics is relatively low compared to the other sites, largely due to the sandy soils and low water retention noted above. Similarly, cover by invasives is low and declining as follow-up control of *Arundo* proceeds.

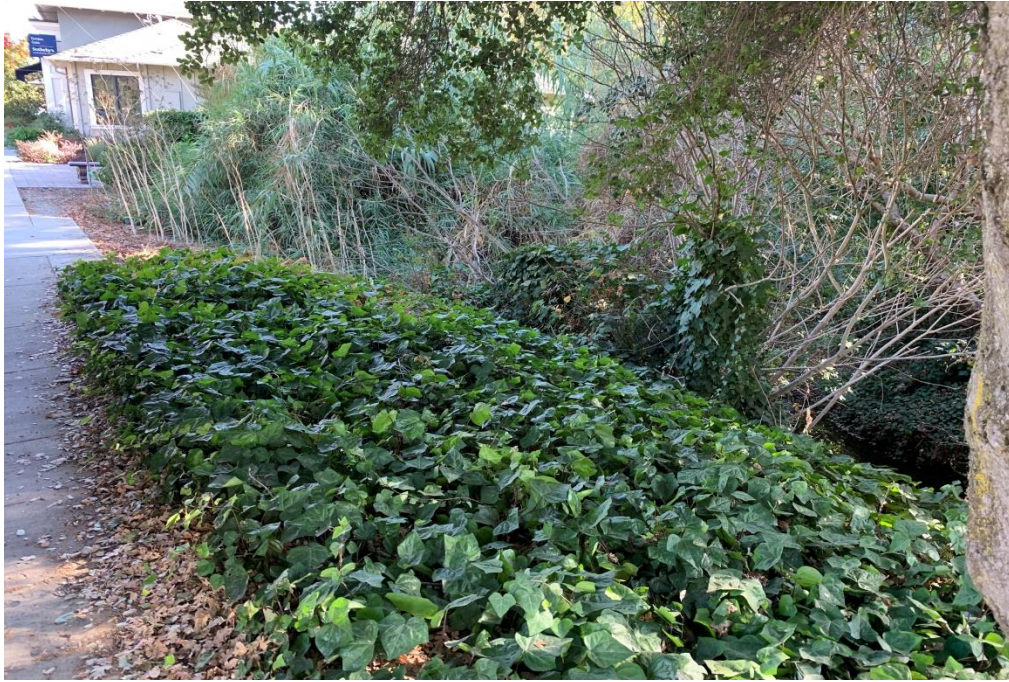
View 7. Lafayette Creek site in December 2019. Note the large stand of Arundo in the background, screening the neighboring building. English ivy covers remainder of site.

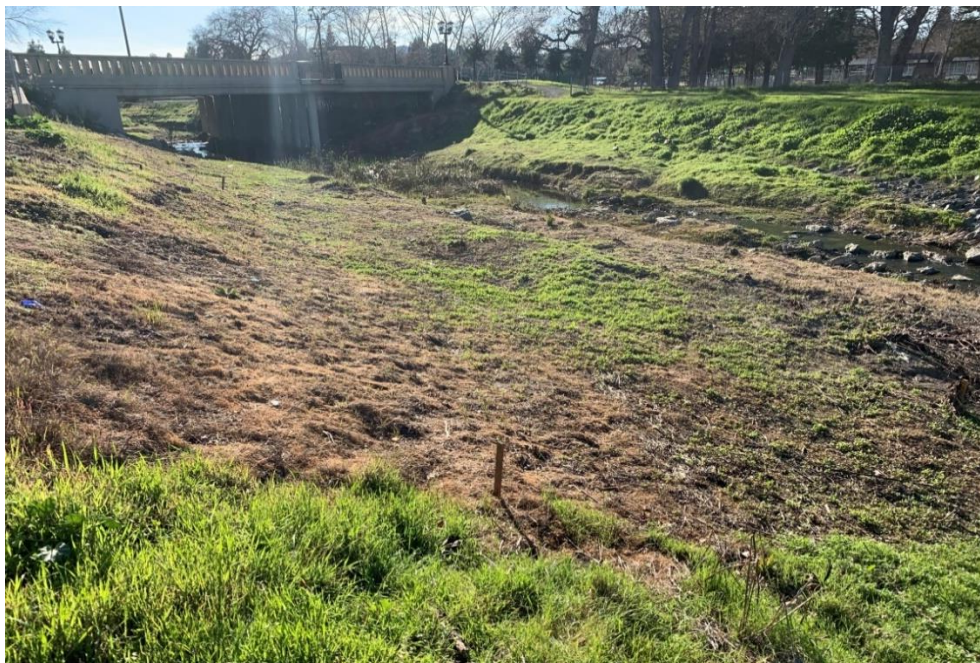
View 10. Grayson Creek site in February 2020 north of the GCR bridge. This photo shows Quad 1 (foreground) and Quad 2 (background), which were sprayed with different herbicides (Roundup in Quad 1 and Weed Slayer in Quad 2). The herbicides used on both Quads controlled nearly 100% of weeds present at that time.

As with the other sites, we began site clearance in December; on this site, though, mowing was the only clearance method used. Herbicide spraying of either Roundup or Weed Slayer was completed on Quads 1 and 2 shortly thereafter as described above (View 10). Planting took place in January 2020 with a large complement of volunteers. We described the spray/no-spray conditions for the four quadrants, and the volunteers eagerly attacked the Quad 3 weeds (View 11).

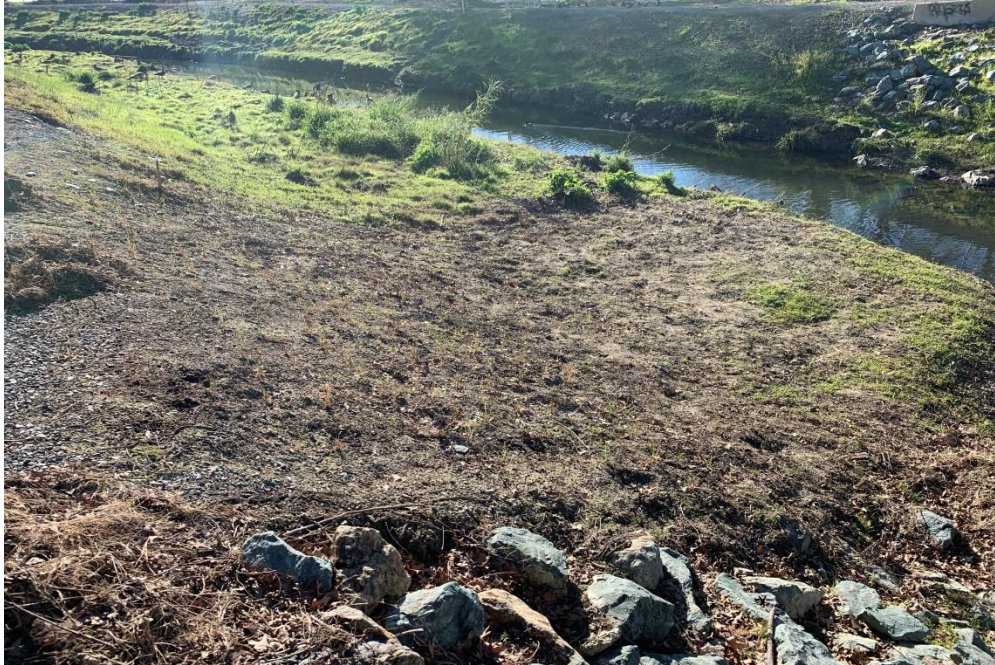
View 11. Grayson Creek site in February 2020 south of the GCR bridge. This photo shows Quad 3 (foreground), which was weeded by volunteers who did an extremely effective job. Quad 4 (background) was not weeded or sprayed.

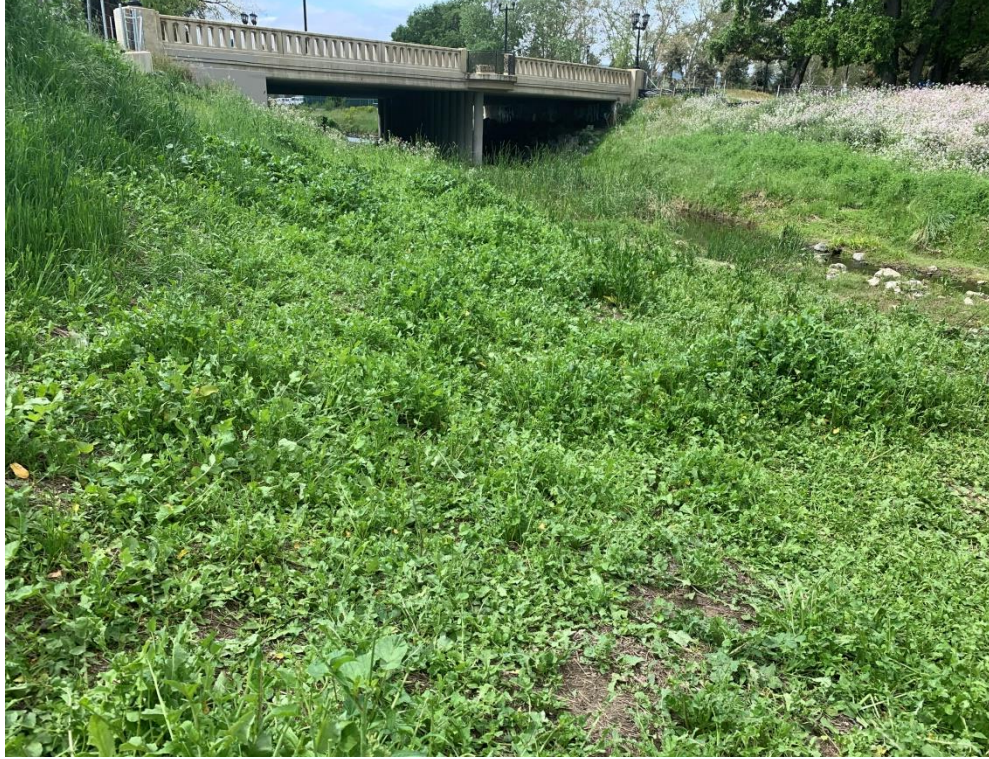
The northern Quads (Quads 1 and 2) at the Grayson Creek site experienced significant weed growth after planting (View 12).

Additionally, a local Canadian goose flock began intensive grazing on all four Quads. The creeping wild rye on the slope was generally spared, but the valley sedge on the terrace was decimated.

View 12. The northern Quads at the Grayson Creek site in May 2020 (same orientation as View 10). Note the dominance of mustard and other weeds.

Absolute plant cover after the restoration effort varies significantly by quadrant. The weed growth and goose grazing reduced native plant cover significantly. However, this site provided some valuable lessons. First, we learned that on open sunny sites, we should expect significant weed growth after site clearance (and soil disturbance) and plan accordingly. Second, where
